Conditional Will Serve Letter
APN: 014-005-340 – 22433 South State Highway 29, Middletown, CA.
Middletown Rancheria 45-50 Unit Housing Project

**PHASE I ENVIRONMENTAL SITE ASSESSMENT
OF THE MARTIN RANCH,
22433 HIGHWAY 29, MIDDLETOWN, CALIFORNIA**

**PHASE I ENVIRONMENTAL SITE ASSESSMENT
OF THE SCOTT PROPERTY AT
22033 SOUTH STATE HIGHWAY 29, MIDDLETOWN, CALIFORNIA**

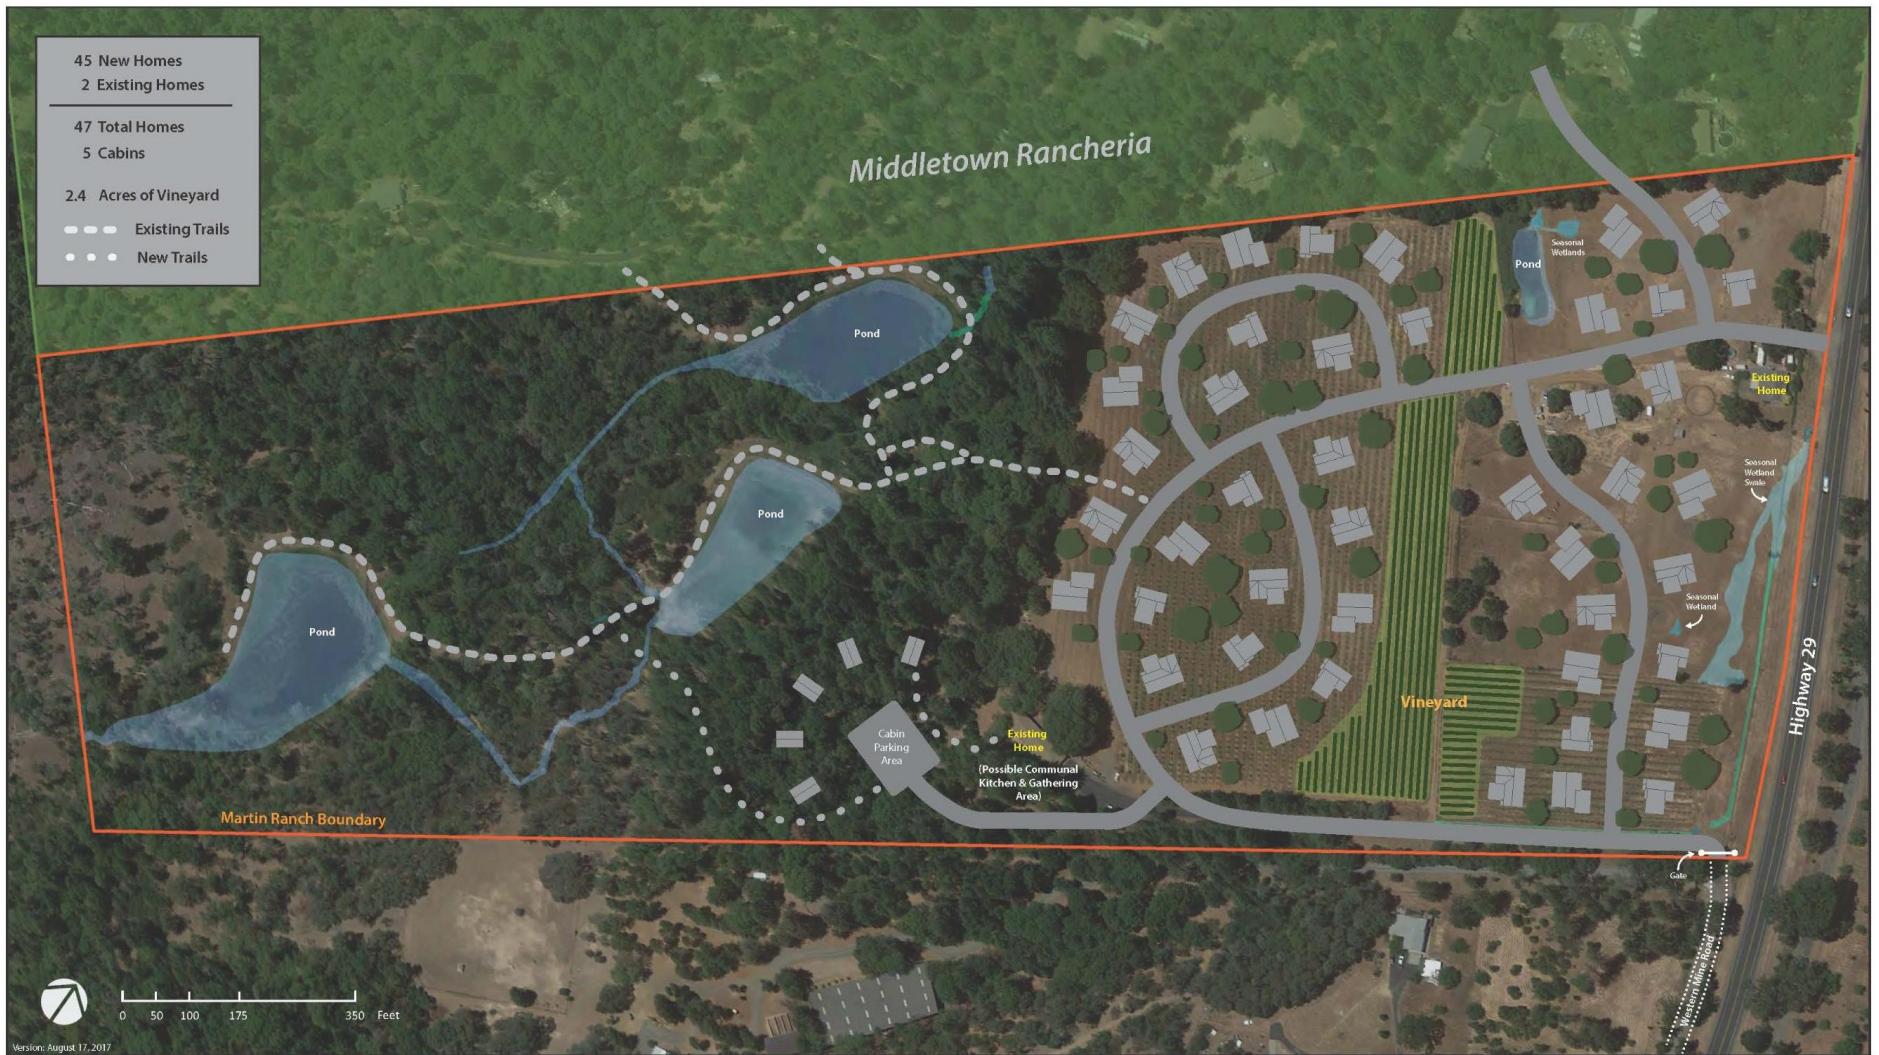
Figure 1
Martin Ranch Site Plan

SITE PLAN

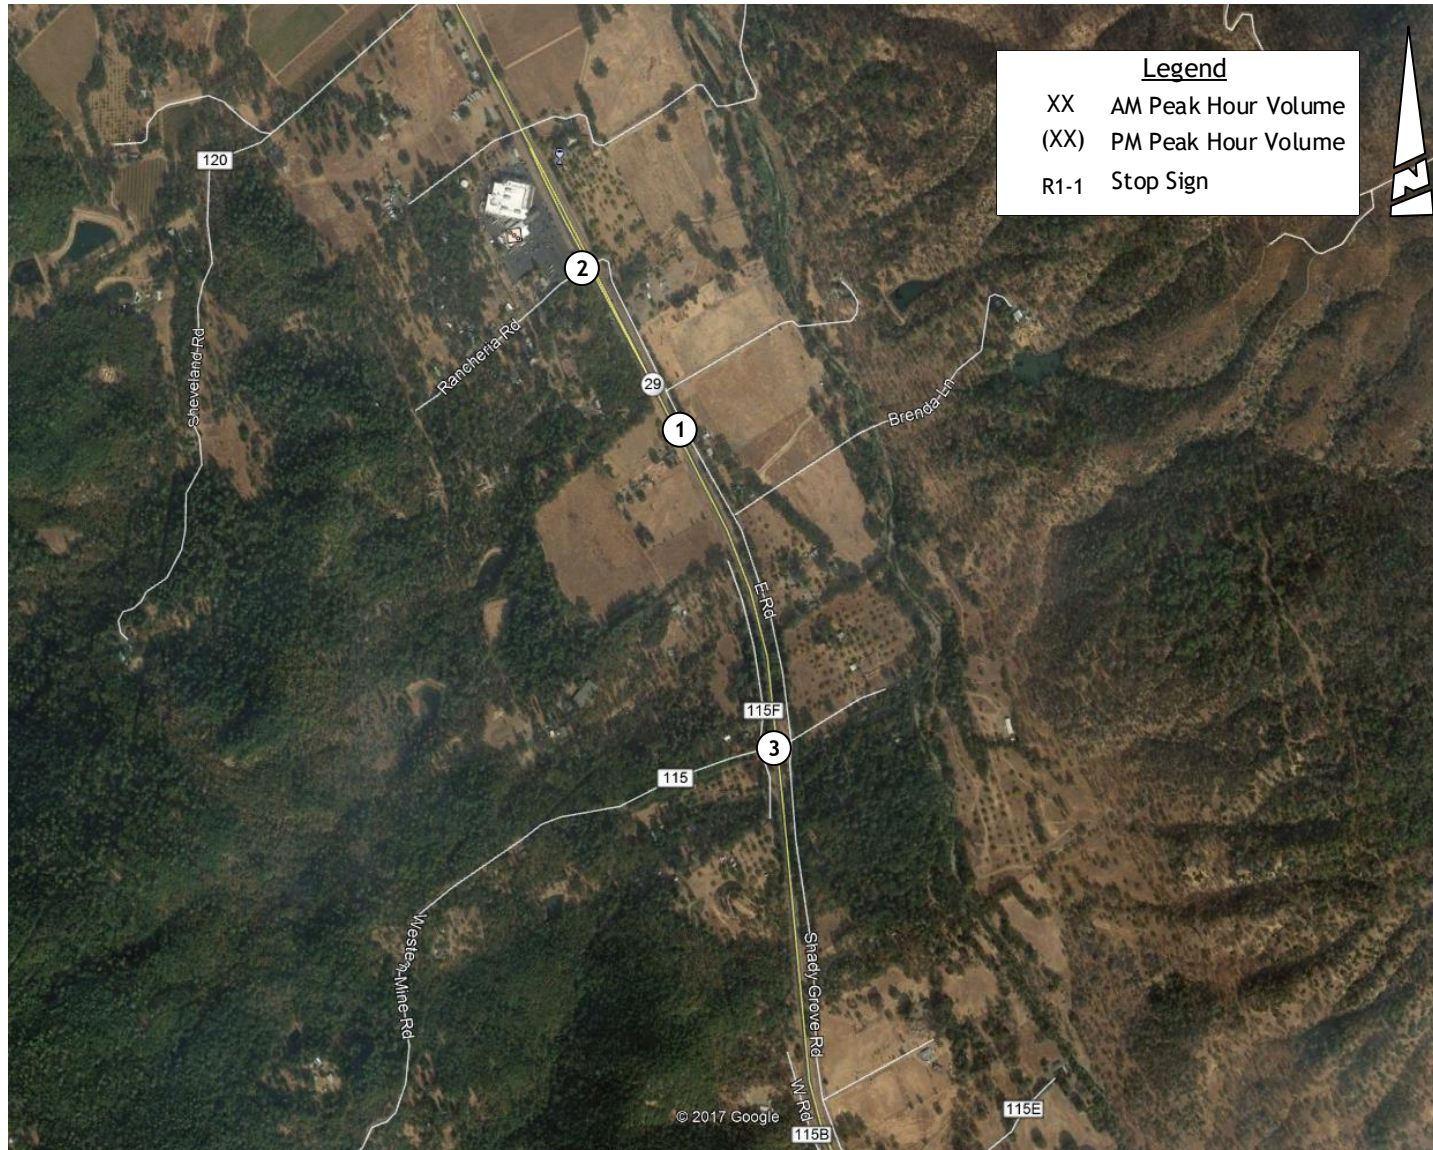
PROJECT ONLY TRAFFIC VOLUMES AND LANE CONFIGURATIONS
 ACCESS OPTION 1 - RANCHERIA RD AND WESTERN MINE RD

Figure 4 presents the peak hour traffic volume forecasts with project access via Western Mine Road and Rancheria Road. Figure 5 presents the project traffic volume forecasts with access at Western Mine Road and the Martin Ranch driveway; Rancheria Road will provide access for the RV park. Figure 6 presents the traffic volume forecast with access at Rancheria Road and the Martin Ranch driveway. Figure 7, the reduced density alternative, presents the peak hour volume forecasts with project access via Western Mine Road and Rancheria Road.

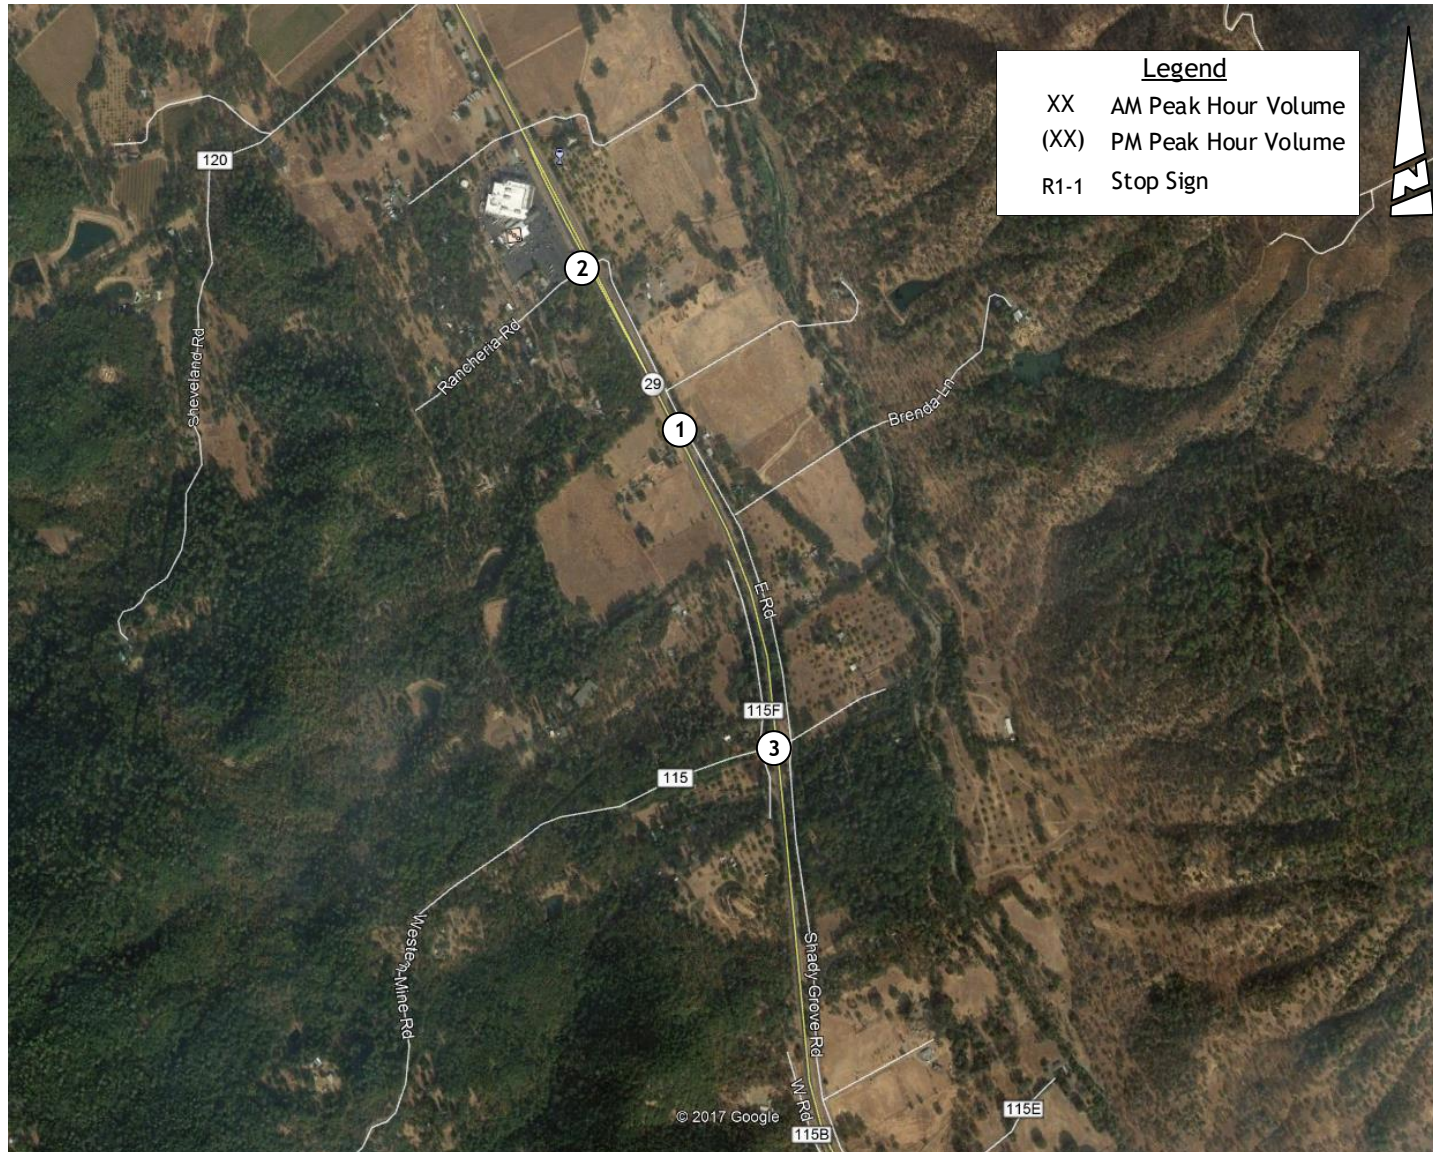
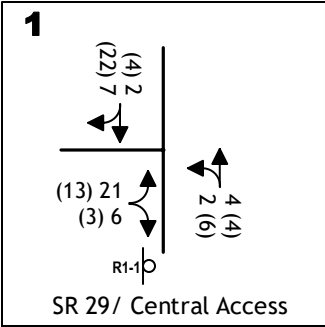
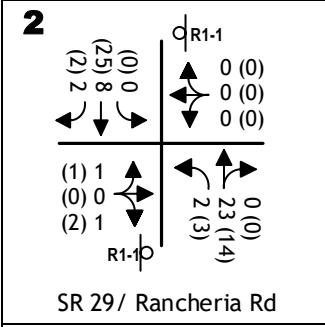
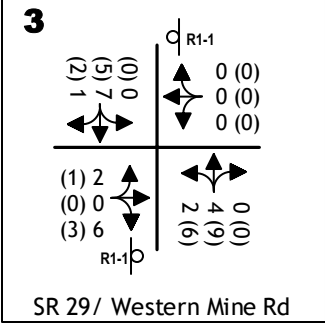
PROJECT ONLY TRAFFIC VOLUMES AND LANE CONFIGURATIONS
 ACCESS OPTION 2 - CENTRAL ACCESS AND WESTERN MINE RD

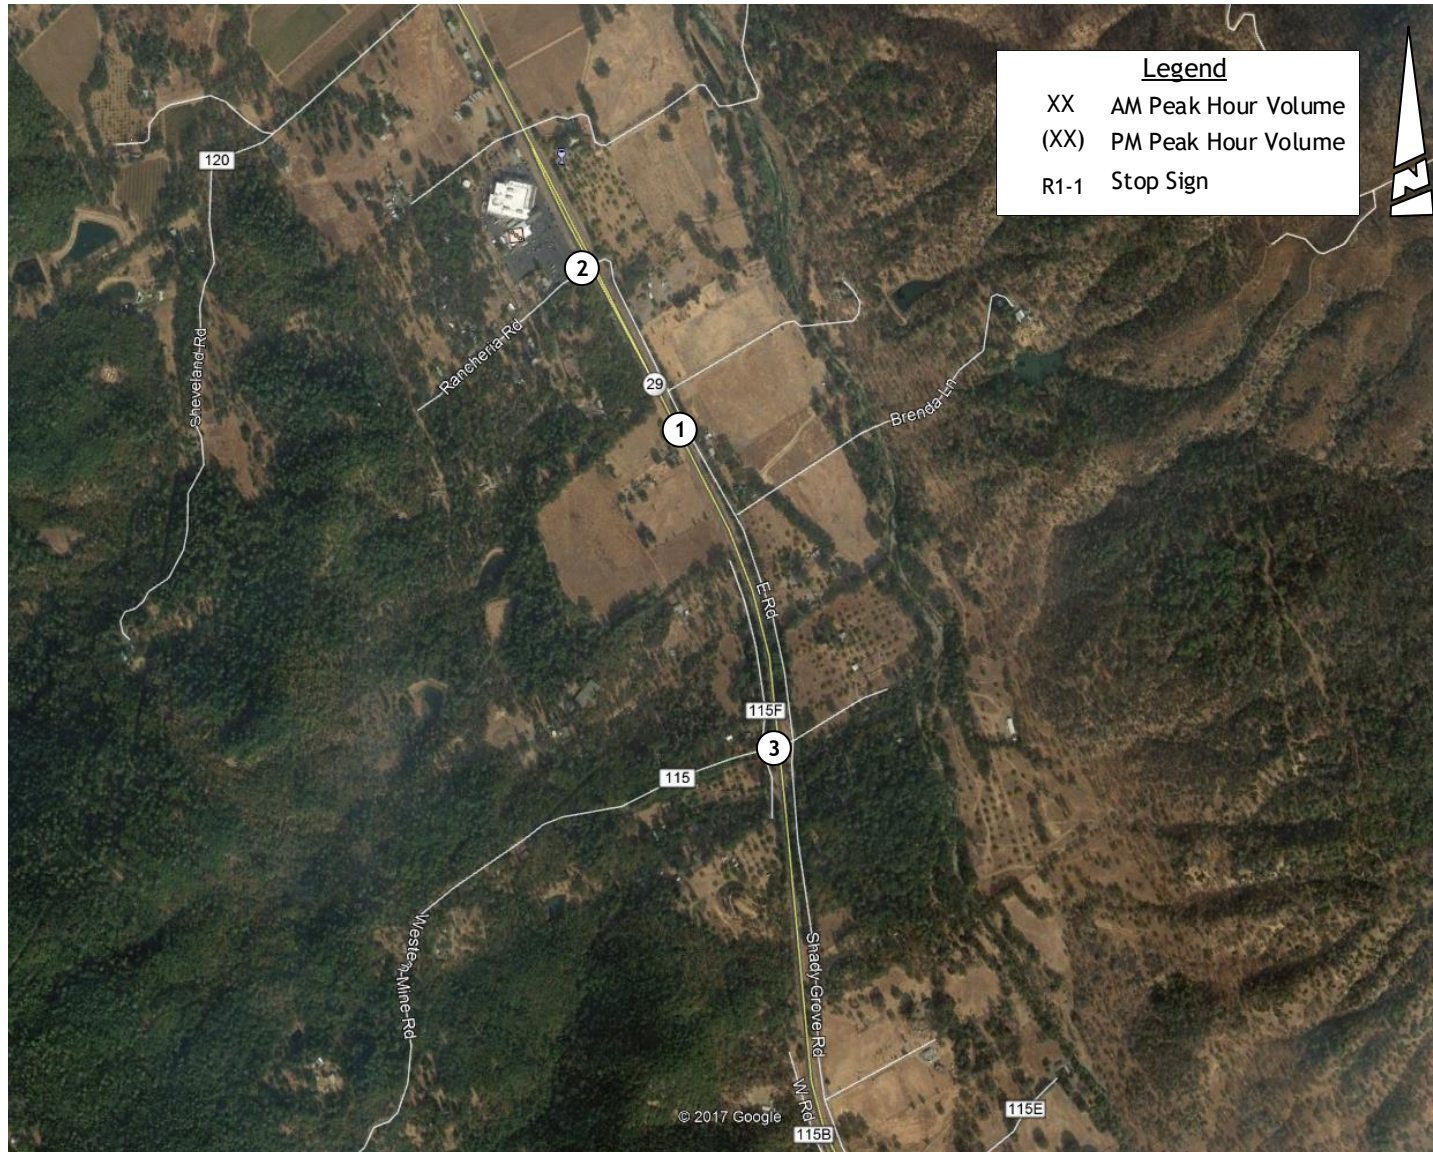
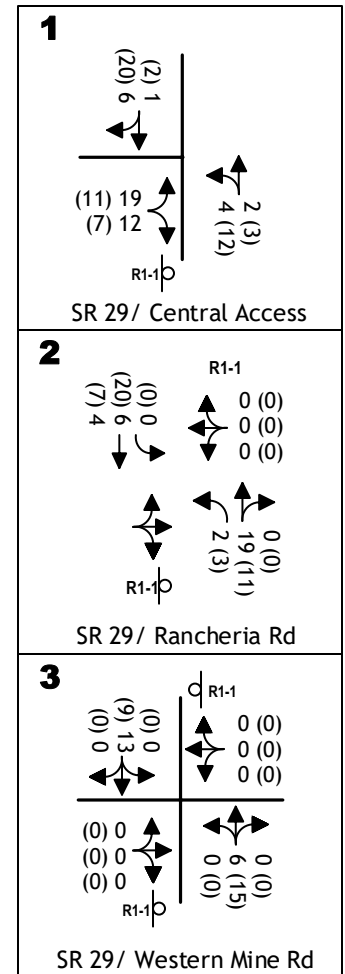
**PROJECT ONLY TRAFFIC VOLUMES AND LANE CONFIGURATIONS
ACCESS OPTION 3 - RANCHERIA RD AND CENTRAL ACCESS**

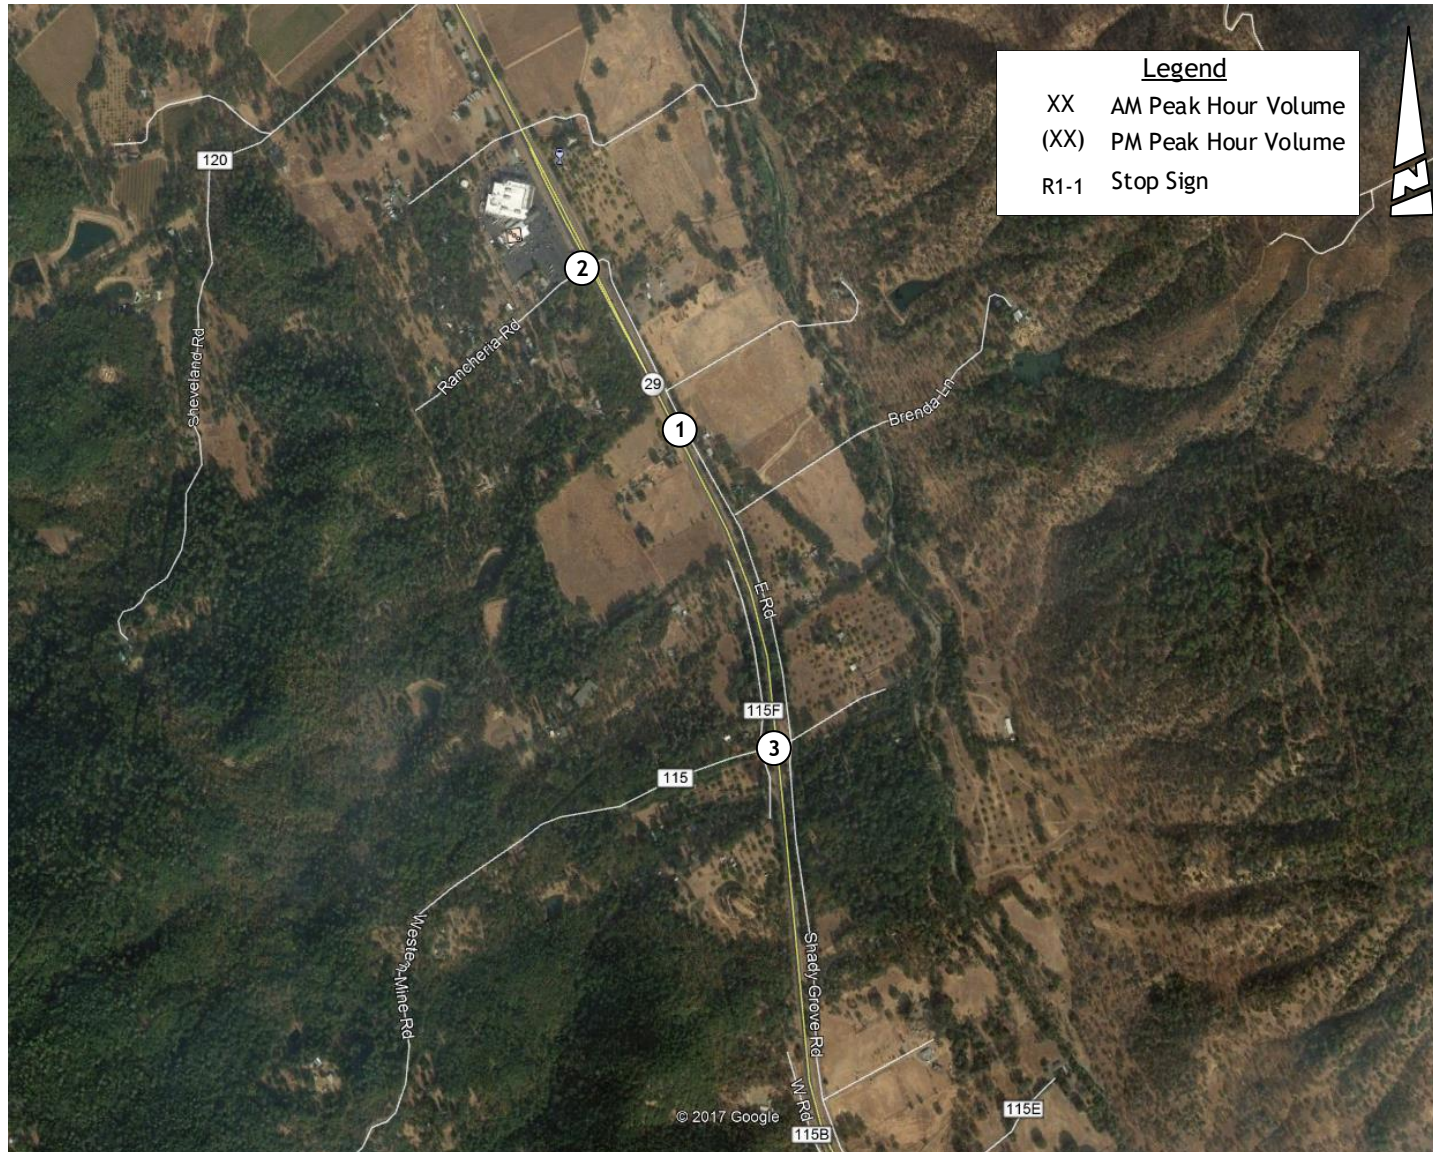
PROJECT ONLY TRAFFIC VOLUMES AND LANE CONFIGURATIONS
 REDUCED DENSITY ALTERNATIVE WITH ACCESS OPTION 1

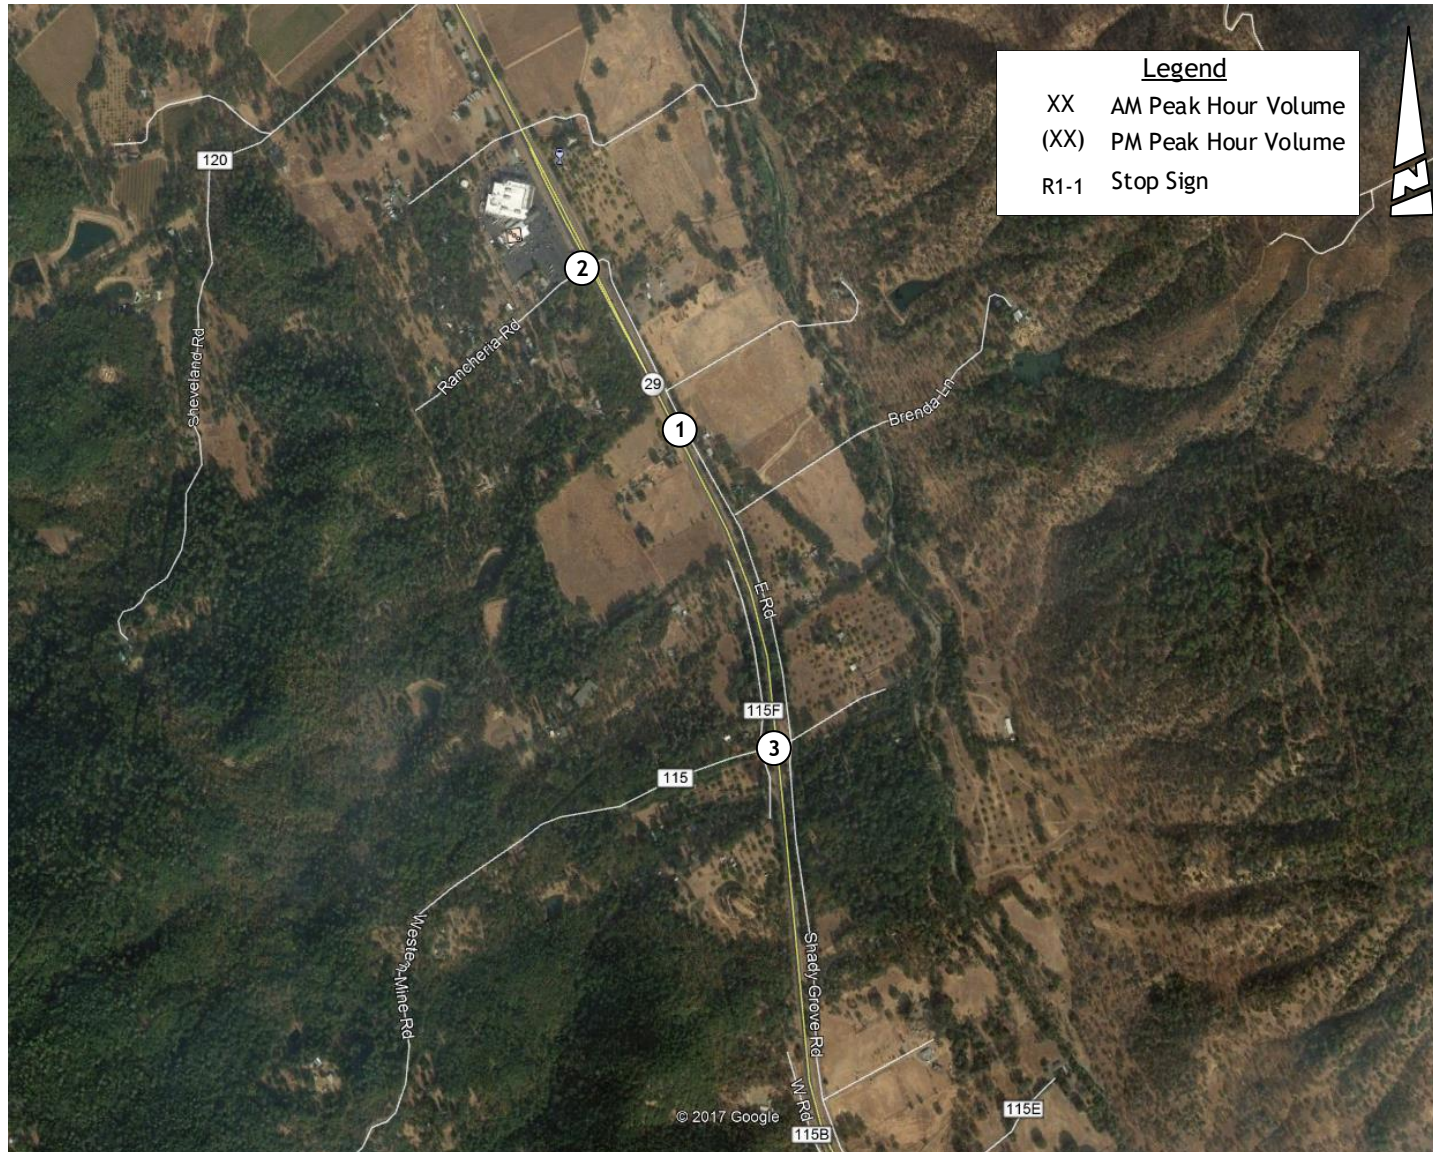
EXISTING PLUS PROJECT TRAFFIC VOLUMES AND LANE CONFIGURATIONS
ACCESS OPTION 1 RANCHERIA RD AND WESTERN MINE RD

TABLE 5 EXISTING PLUS PROJECT PEAK HOUR LEVELS OF SERVICE ACCESS OPTION #1 – WESTERN MINE ROAD AND RANCHERIA ROAD ACCESS									
Location	Control	AM Peak Hour				PM Peak Hour			
		Existing		Ex Plus Project (Opt #1 – Western Mine Rd & Rancheria Rd Access)		Existing		Ex Plus Project (Opt #1 – Western Mine Rd & Rancheria Rd Access)	
		LOS	Average Delay (sec/veh)	LOS	Average Delay (sec/veh)	LOS	Average Delay (sec/veh)	LOS	Average Delay (sec/veh)
2. SR 29 / Rancheria Road									
NB left		A	8.5	A	8.5	A	8.0	A	8.1
SB left		A	7.5	A	7.5	A	8.5	A	8.5
EB	EB/WB	C	15.3	C	16.7	D	26.1	D	30.7
WB	Stop	A	8.9	A	8.9	C	15.3	C	15.7
3. SR 29 / Western Mine Rd									
NB left		---	---	A	8.5	A	7.6	A	7.6
SB left		---	---	---	---	A	8.8	A	8.9
EB	EB/WB	B	13.2	B	12.9	C	17.6	C	15.4
WB	Stop	B	11.6	B	11.9	B	12.6	B	12.7

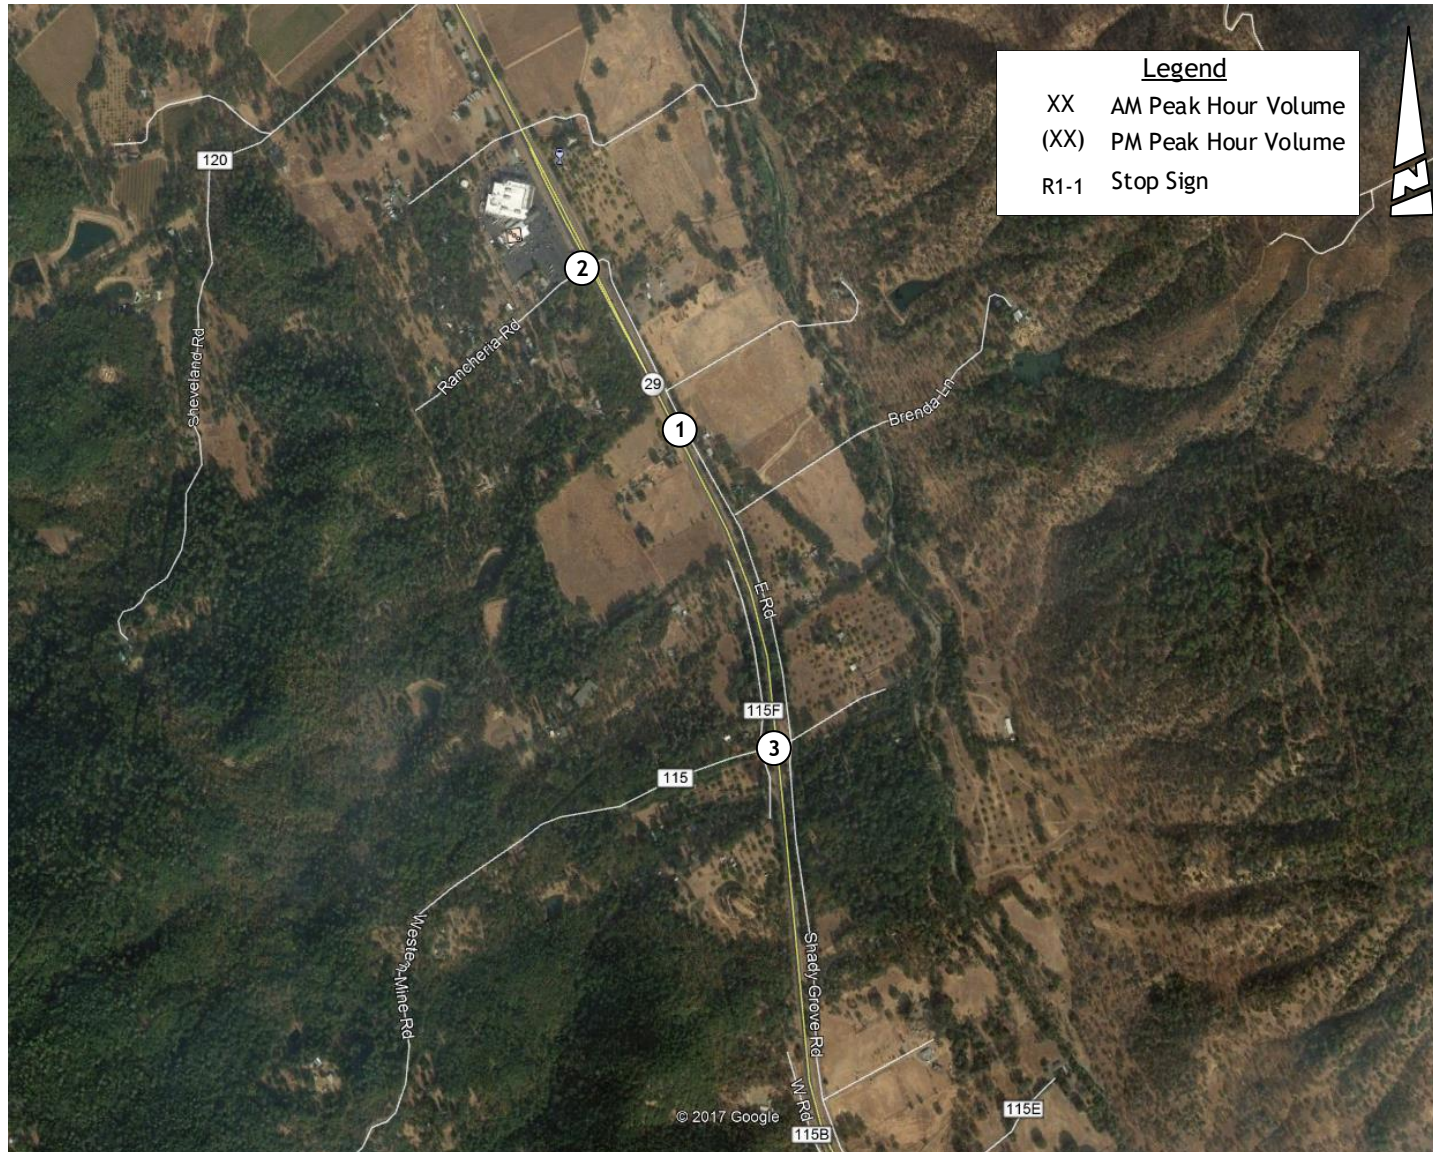
EXISTING PLUS PROJECT TRAFFIC VOLUMES AND LANE CONFIGURATIONS
 ACCESS OPTION 2 - CENTRAL ACCESS AND WESTERN MINE RD

TABLE 6 EXISTING PLUS PROJECT PEAK HOUR LEVELS OF SERVICE ACCESS OPTION #2 – WESTERN MINE ROAD ACCESS									
Location	Control	AM Peak Hour				PM Peak Hour			
		Existing		Ex Plus Project (Opt #2 – Western Mine Rd Access)		Existing		Ex Plus Project (Opt #2 – Western Mine Rd Access)	
		LOS	Average Delay (sec/veh)	LOS	Average Delay (sec/veh)	LOS	Average Delay (sec/veh)	LOS	Average Delay (sec/veh)
1. SR 29 / Central Access	EB Stop	---	---	A	8.5	---	---	A	7.7
NB left		---	---	B	14.1	---	---	C	16.0
2. SR 29 / Rancheria Road	EB/WB Stop	A	8.5	A	8.5	A	8.0	A	8.1
NB left		A	7.5	A	7.5	A	8.5	A	8.6
SB left		C	15.3	C	16.0	D	26.1	D	29.5
EB		A	8.9	A	9.1	C	15.3	C	15.9
3. SR 29 / Western Mine Rd	EB/WB Stop	---	---	A	8.5	A	7.6	A	7.6
NB left		---	---	---	---	A	8.8	A	8.9
SB left		B	13.2	B	13.1	C	17.6	C	16.6
EB		B	11.6	B	11.9	B	12.6	B	12.7
WB

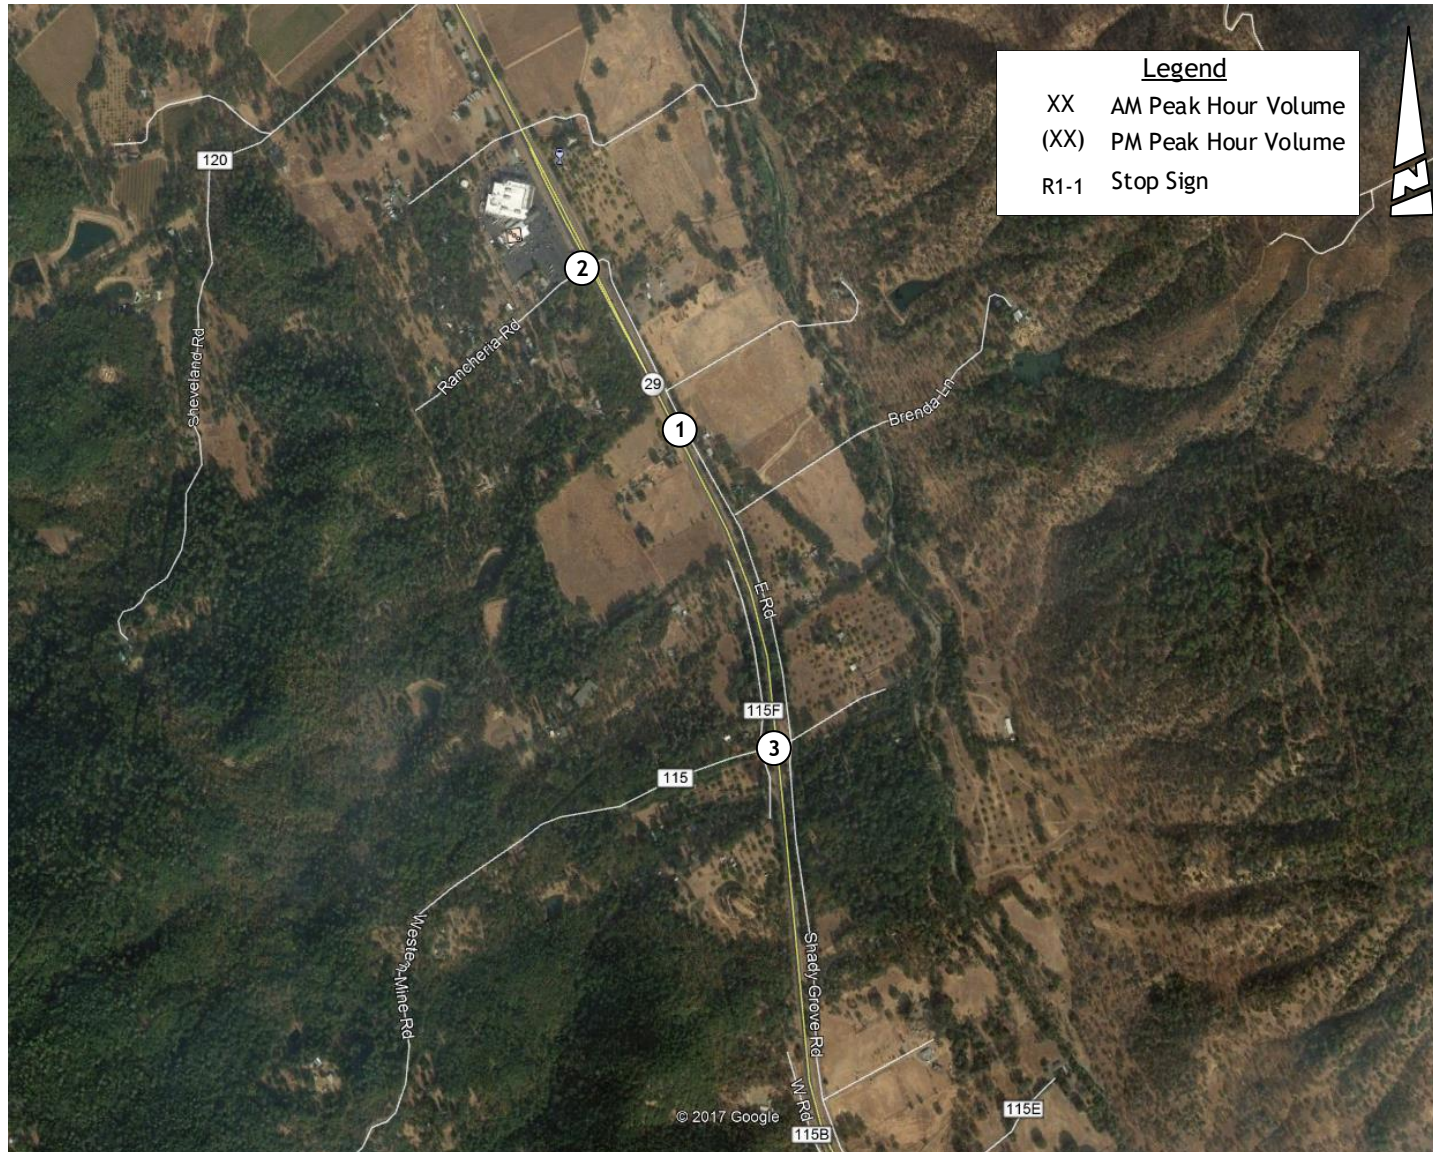
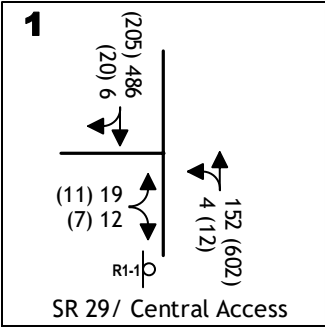
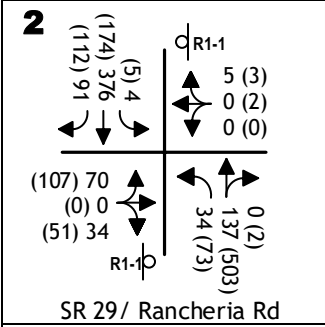
EXISTING PLUS PROJECT TRAFFIC VOLUMES AND LANE CONFIGURATIONS
 ACCESS OPTION 3 - CENTRAL ACCESS AND RANCHERIA RD

TABLE 7 EXISTING PLUS PROJECT PEAK HOUR LEVELS OF SERVICE ACCESS OPTION #3 – RANCHERIA ROAD ACCESS									
Location	Control	AM Peak Hour				PM Peak Hour			
		Existing		Ex Plus Project (Opt #3 – Rancheria Rd Access)		Existing		Ex Plus Project (Opt #3 – Rancheria Rd Access)	
		LOS	Average Delay (sec/veh)	LOS	Average Delay (sec/veh)	LOS	Average Delay (sec/veh)	LOS	Average Delay (sec/veh)
1. SR 29 / Central Access	EB Stop	---	---	A	8.5	---	---	A	7.8
NB left		---	---	B	13.7	---	---	B	14.6
EB									
2. SR 29 / Rancheria Road	EB/WB Stop	A	8.5	A	8.5	A	8.0	A	8.1
NB left		A	7.5	A	7.5	A	8.5	A	8.5
SB left		C	15.3	C	16.3	D	26.1	D	30.0
EB		A	8.9	A	9.0	C	15.3	C	15.8
WB									
3. SR 29 / Western Mine Rd	EB/WB Stop	---	---	---	---	A	7.6	A	7.6
NB left		---	---	---	---	A	8.8	A	8.9
SB left		B	13.2	B	13.5	C	17.6	C	18.1
EB		B	11.6	B	11.8	B	12.6	B	12.8
WB

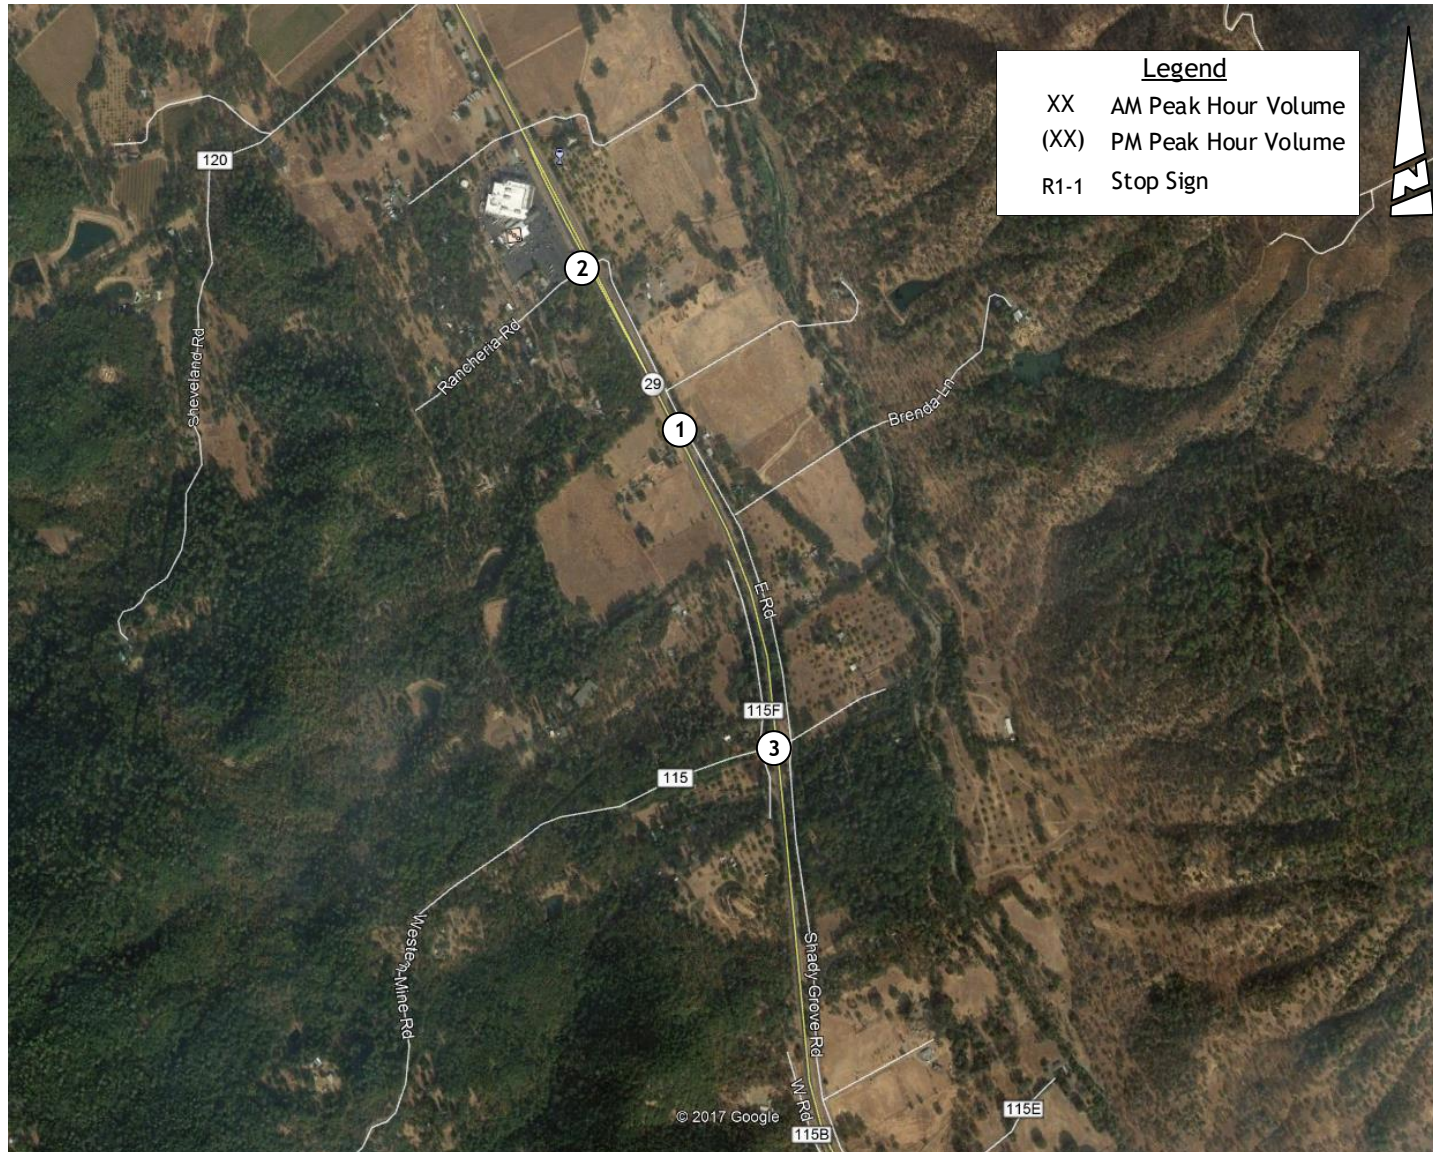
EXISTING PLUS PROJECT TRAFFIC VOLUMES AND LANE CONFIGURATIONS
 REDUCED DENSITY ALTERNATIVE WITH ACCESS OPTION 1

TABLE 8 EXISTING PLUS PROJECT PEAK HOUR LEVELS OF SERVICE REDUCED DENSITY ALTERNATIVE –WESTERN MINE RD AND RANCHERIA RD ACCESS										
Location	Control	AM Peak Hour				PM Peak Hour				
		Existing		Ex Plus Project (Reduced Density)		Existing		Ex Plus Project (Reduced Density)		
		LOS	Average Delay (sec/veh)	LOS	Average Delay (sec/veh)	LOS	Average Delay (sec/veh)	LOS	Average Delay (sec/veh)	
2. SR 29 / Rancheria Road	EB/WB Stop	NB left	A	8.5	A	8.5	A	8.0	A	8.0
SB left		A	7.5	A	7.5	A	8.5	A	8.5	
EB		C	15.3	C	16.2	D	26.1	D	28.6	
WB		A	8.9	A	8.9	C	15.3	C	15.5	
3. SR 29 / Western Mine Rd	EB/WB Stop	NB left	---	---	A	8.5	A	7.6	A	7.6
SB left		---	---	---	---	A	8.8	A	8.9	
EB		B	13.2	B	12.8	C	17.6	C	16.4	
WB		B	11.6	B	11.8	B	12.6	B	12.7

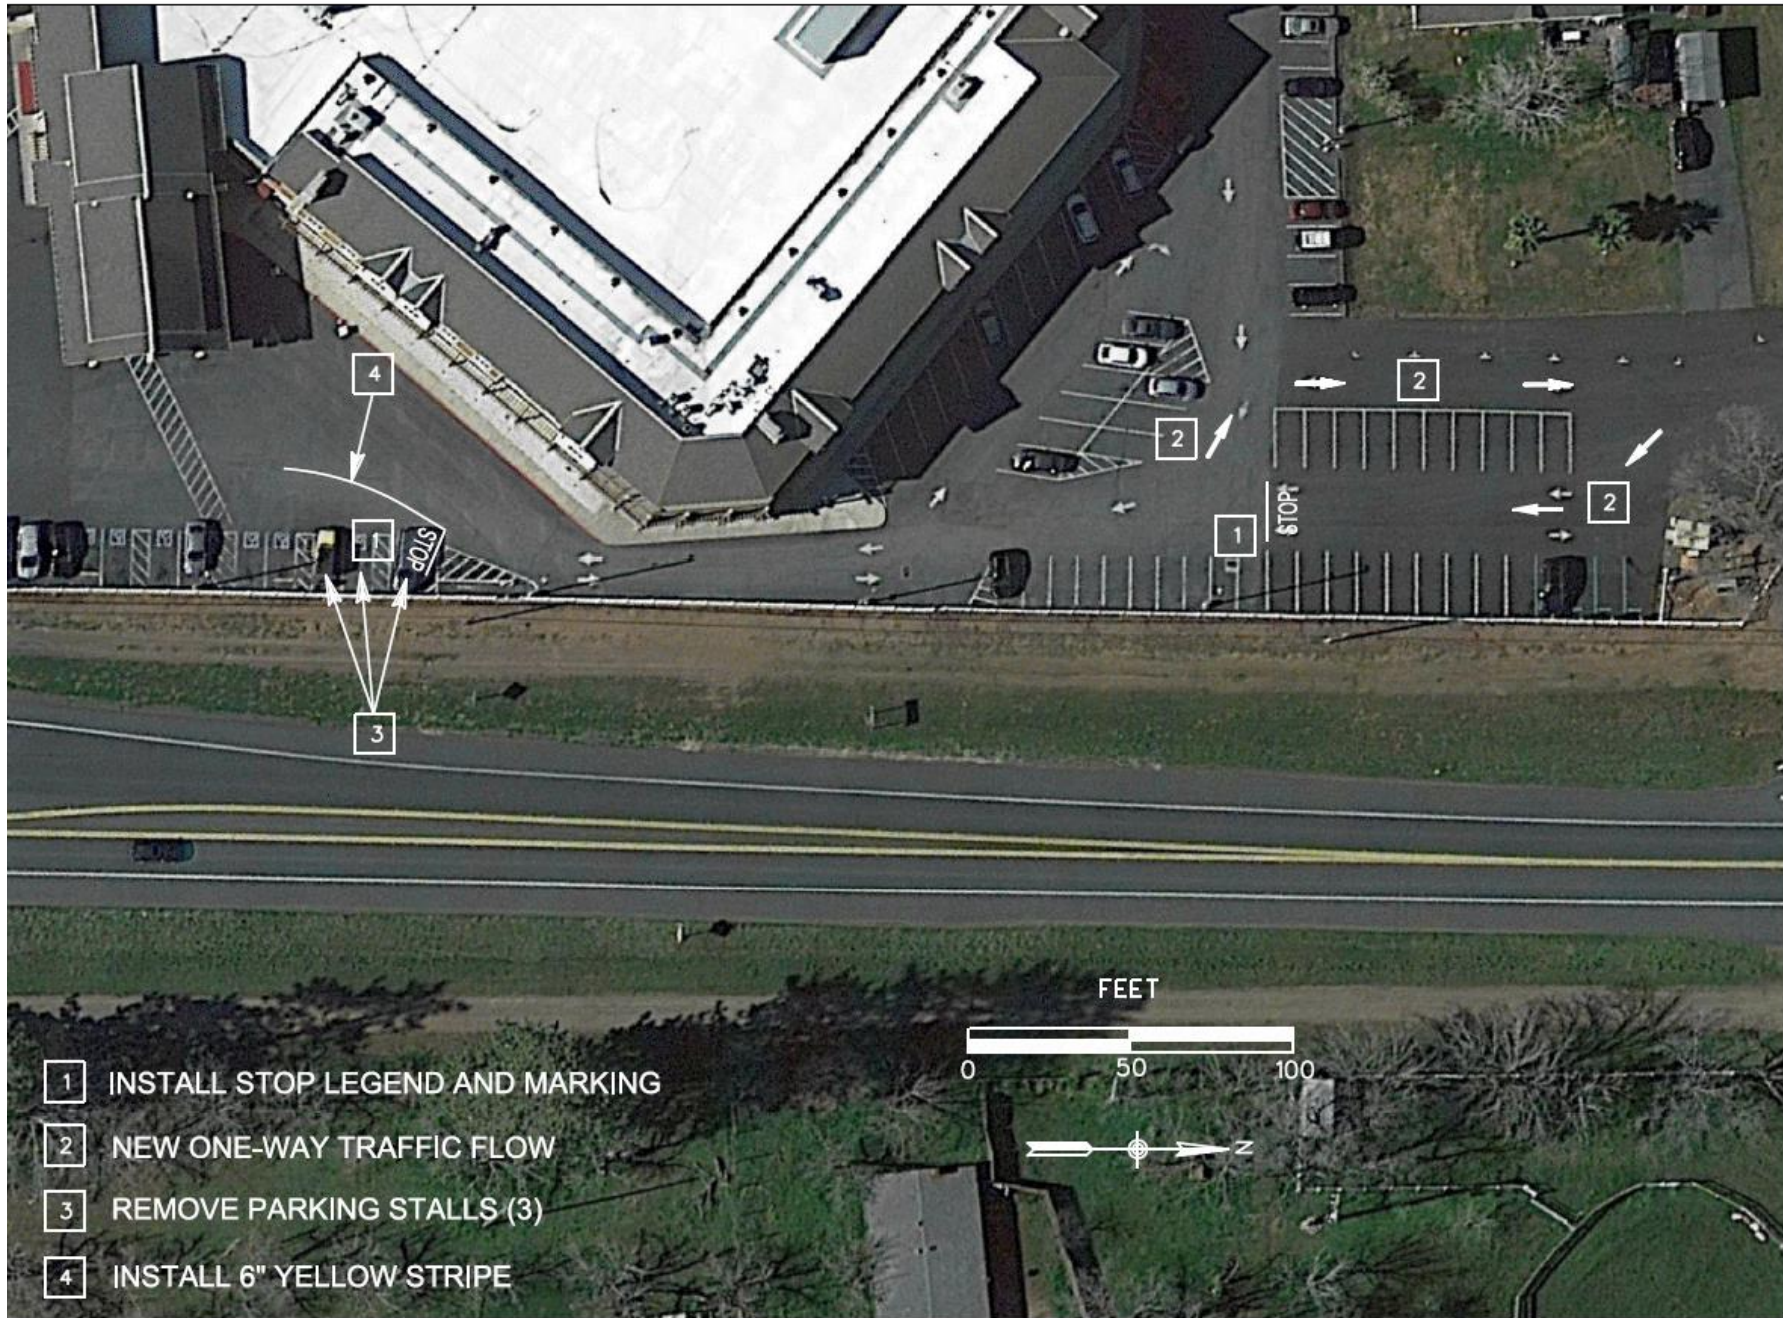
AUTOTURN (MOTORHOME) - CHOKER POINT DETAIL

This alignment minimizes the removal of parking spaces; however, alternatives are available that would require additional restriping and could result in a loss of additional parking.

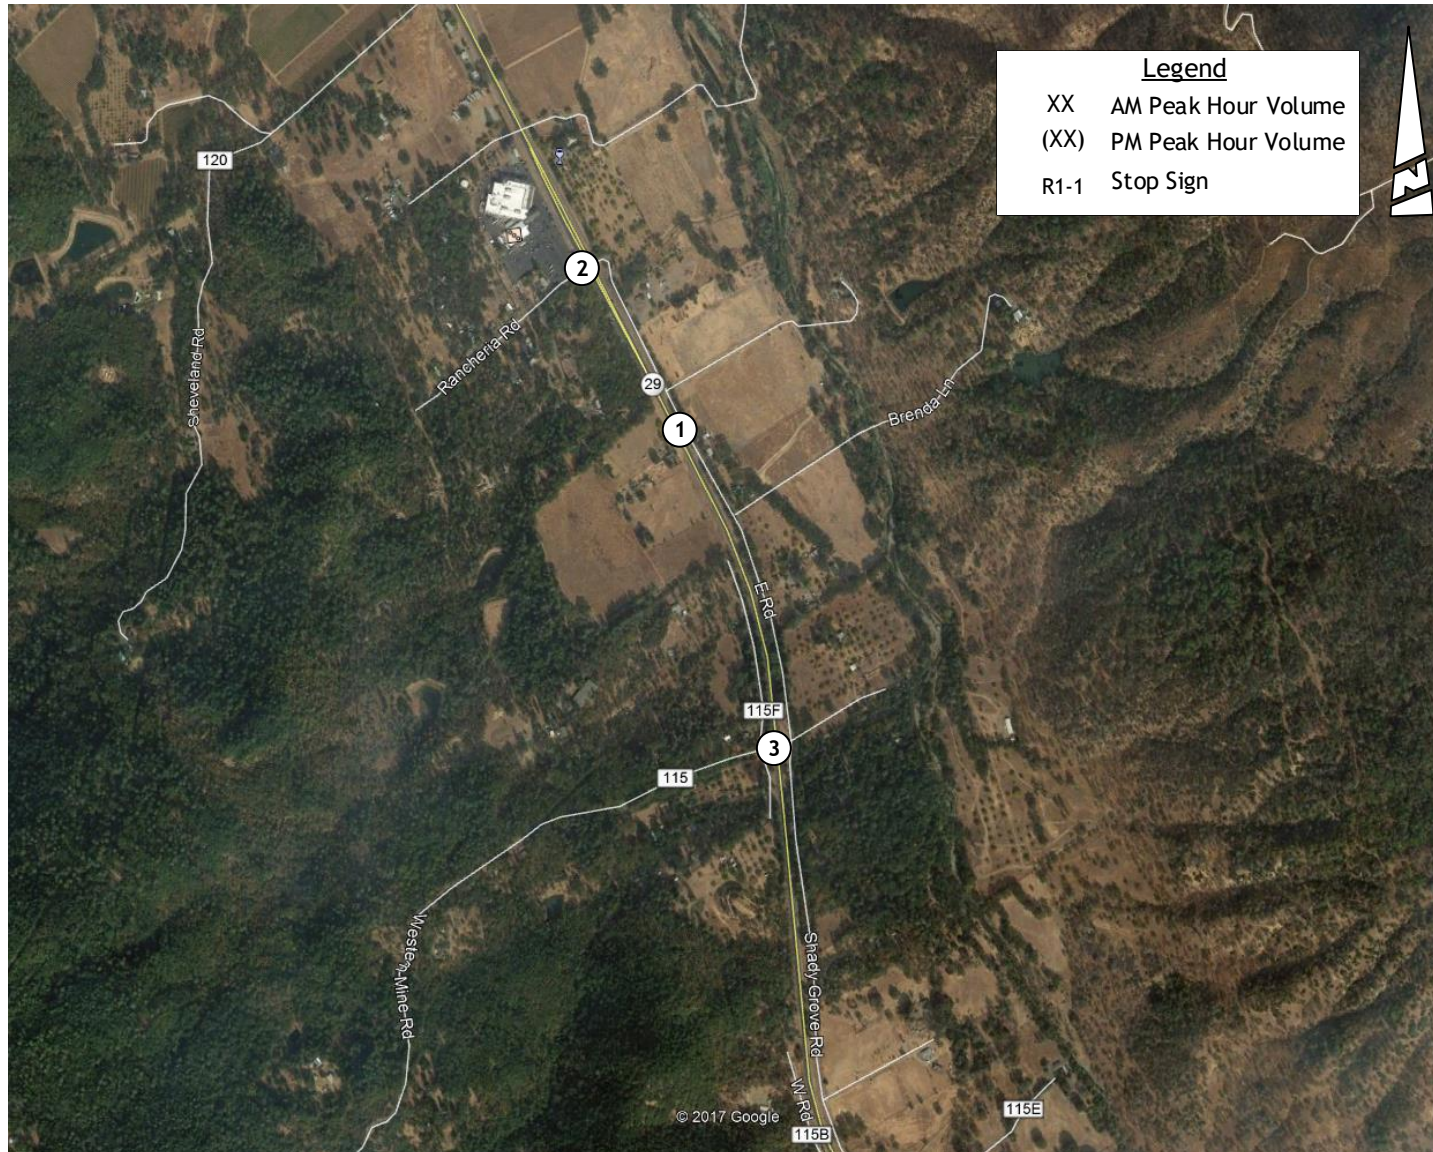
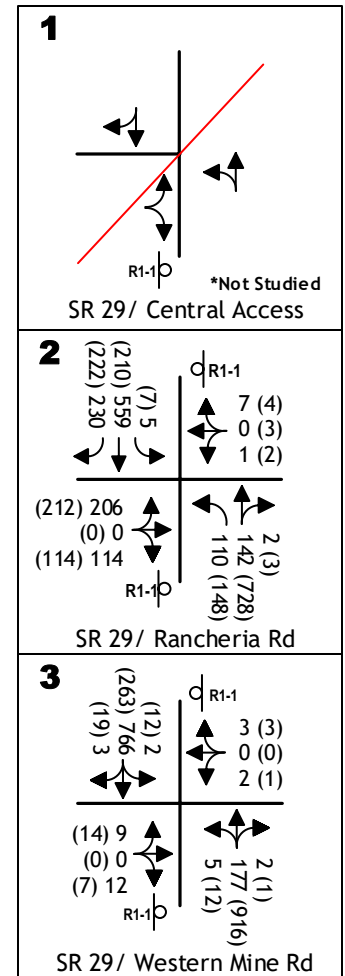
CUMULATIVE PLUS PROJECT TRAFFIC VOLUMES AND LANE CONFIGURATIONS
 ACCESS OPTION 1 - RANCHERIA RD AND WESTERN MINE RD
