Conditional Will Serve Letter
APN: 014-005-340 – 22433 South State Highway 29, Middletown, CA.
Middletown Rancheria 45-50 Unit Housing Project

**PHASE I ENVIRONMENTAL SITE ASSESSMENT
OF THE MARTIN RANCH,
22433 HIGHWAY 29, MIDDLETOWN, CALIFORNIA**

**PHASE I ENVIRONMENTAL SITE ASSESSMENT
OF THE SCOTT PROPERTY AT
22033 SOUTH STATE HIGHWAY 29, MIDDLETOWN, CALIFORNIA**

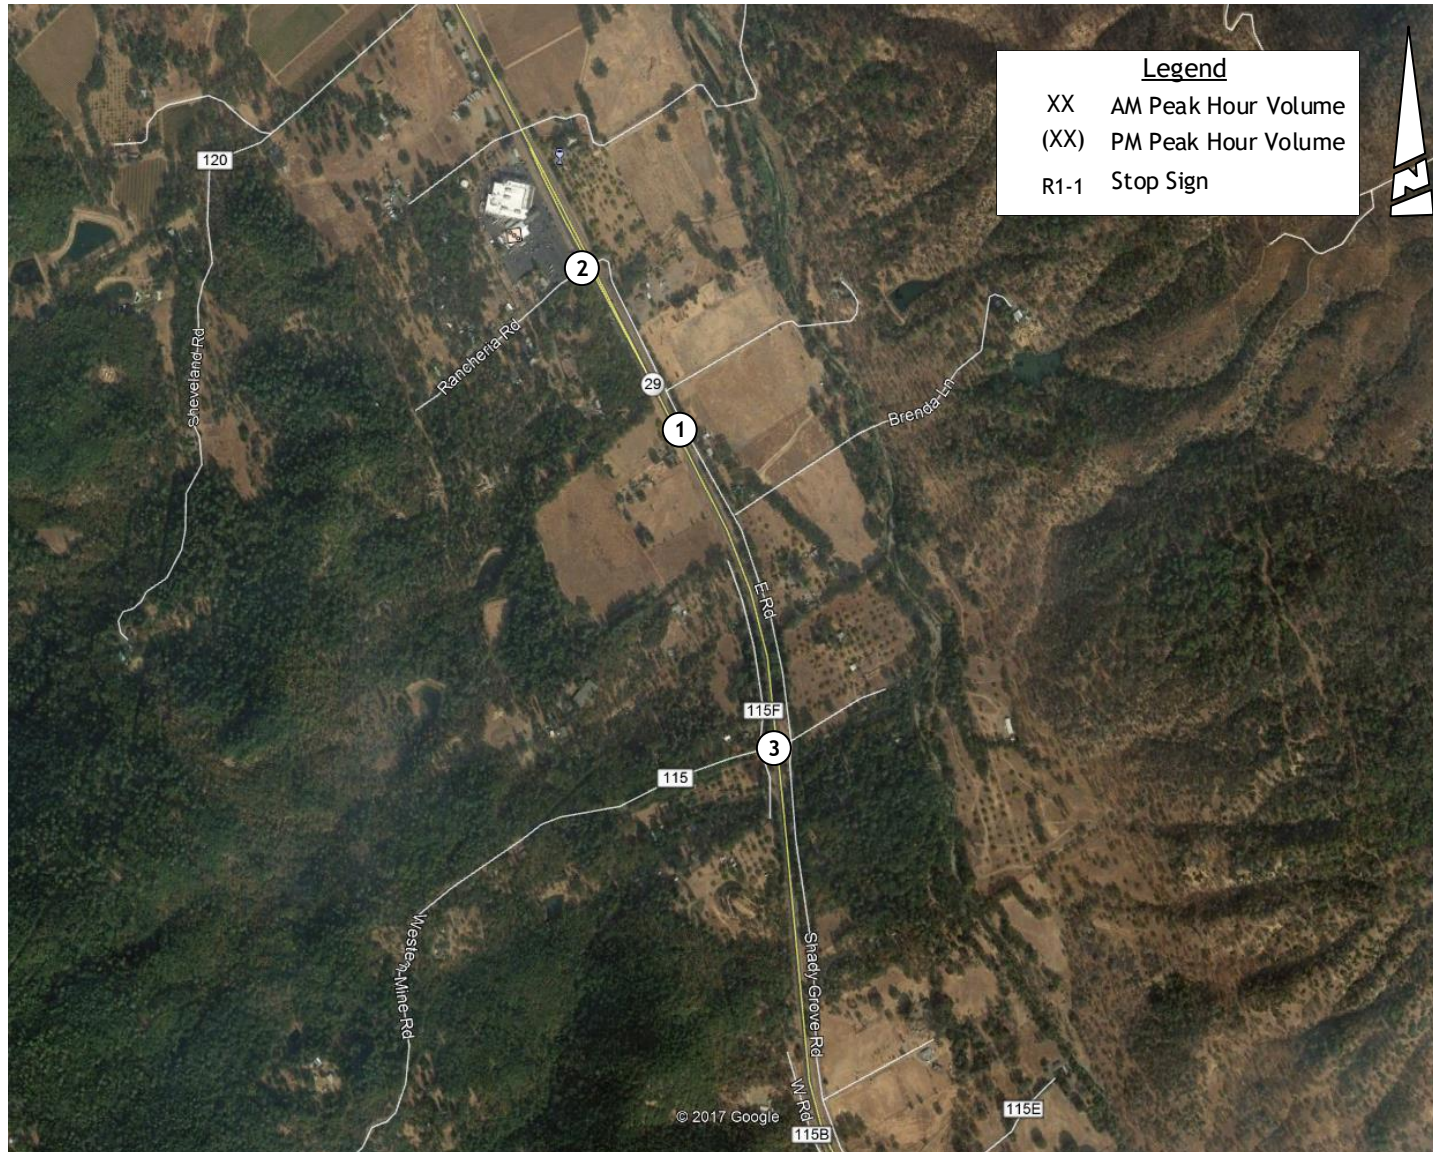
CUMULATIVE PLUS PROJECT TRAFFIC VOLUMES AND LANE CONFIGURATIONS
ACCESS OPTION 2 - CENTRAL ACCESS AND WESTERN MINE RD

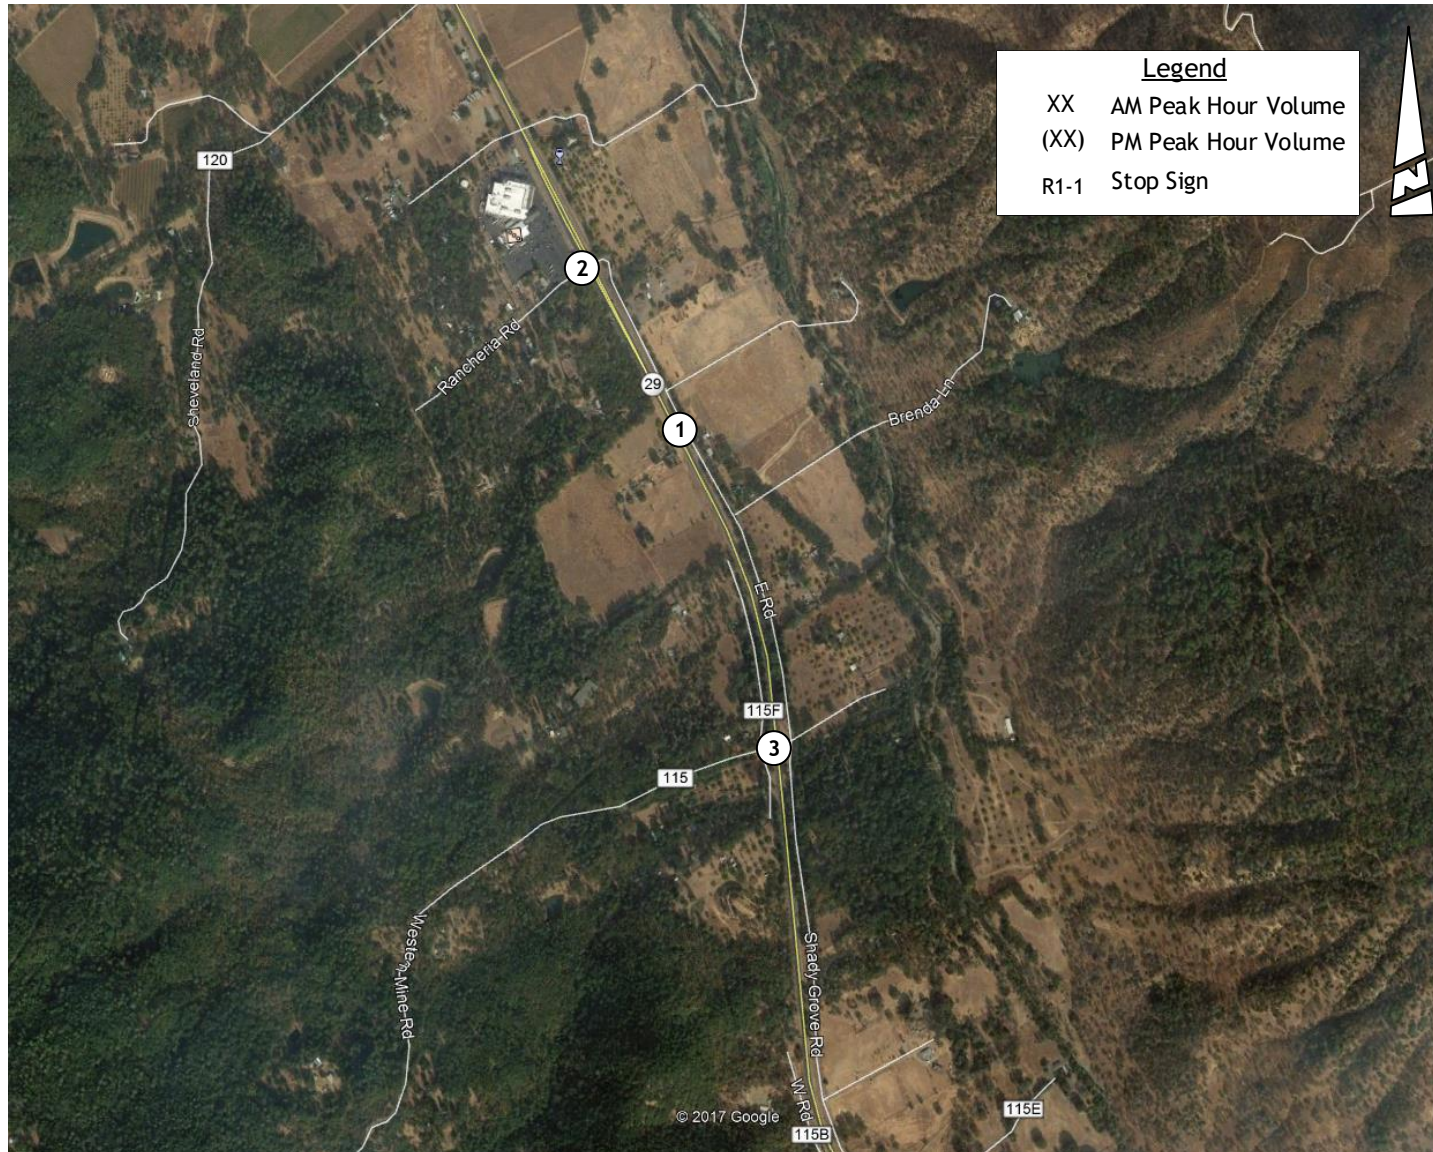
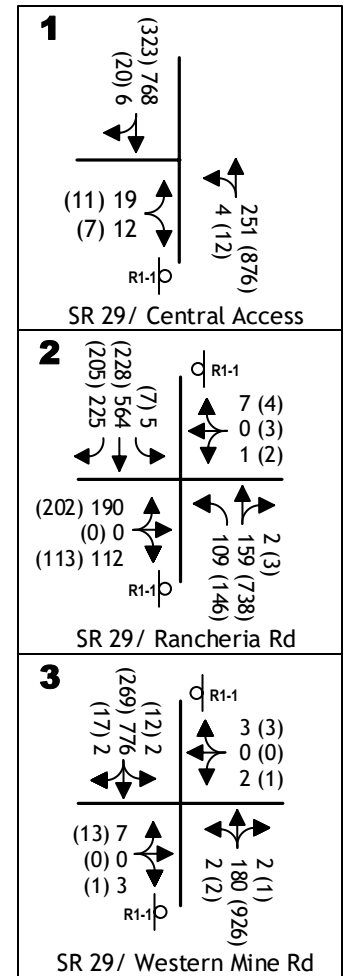
CUMULATIVE PLUS PROJECT TRAFFIC VOLUMES AND LANE CONFIGURATIONS
ACCESS OPTION 3 - CENTRAL ACCESS AND RANCHERIA RD

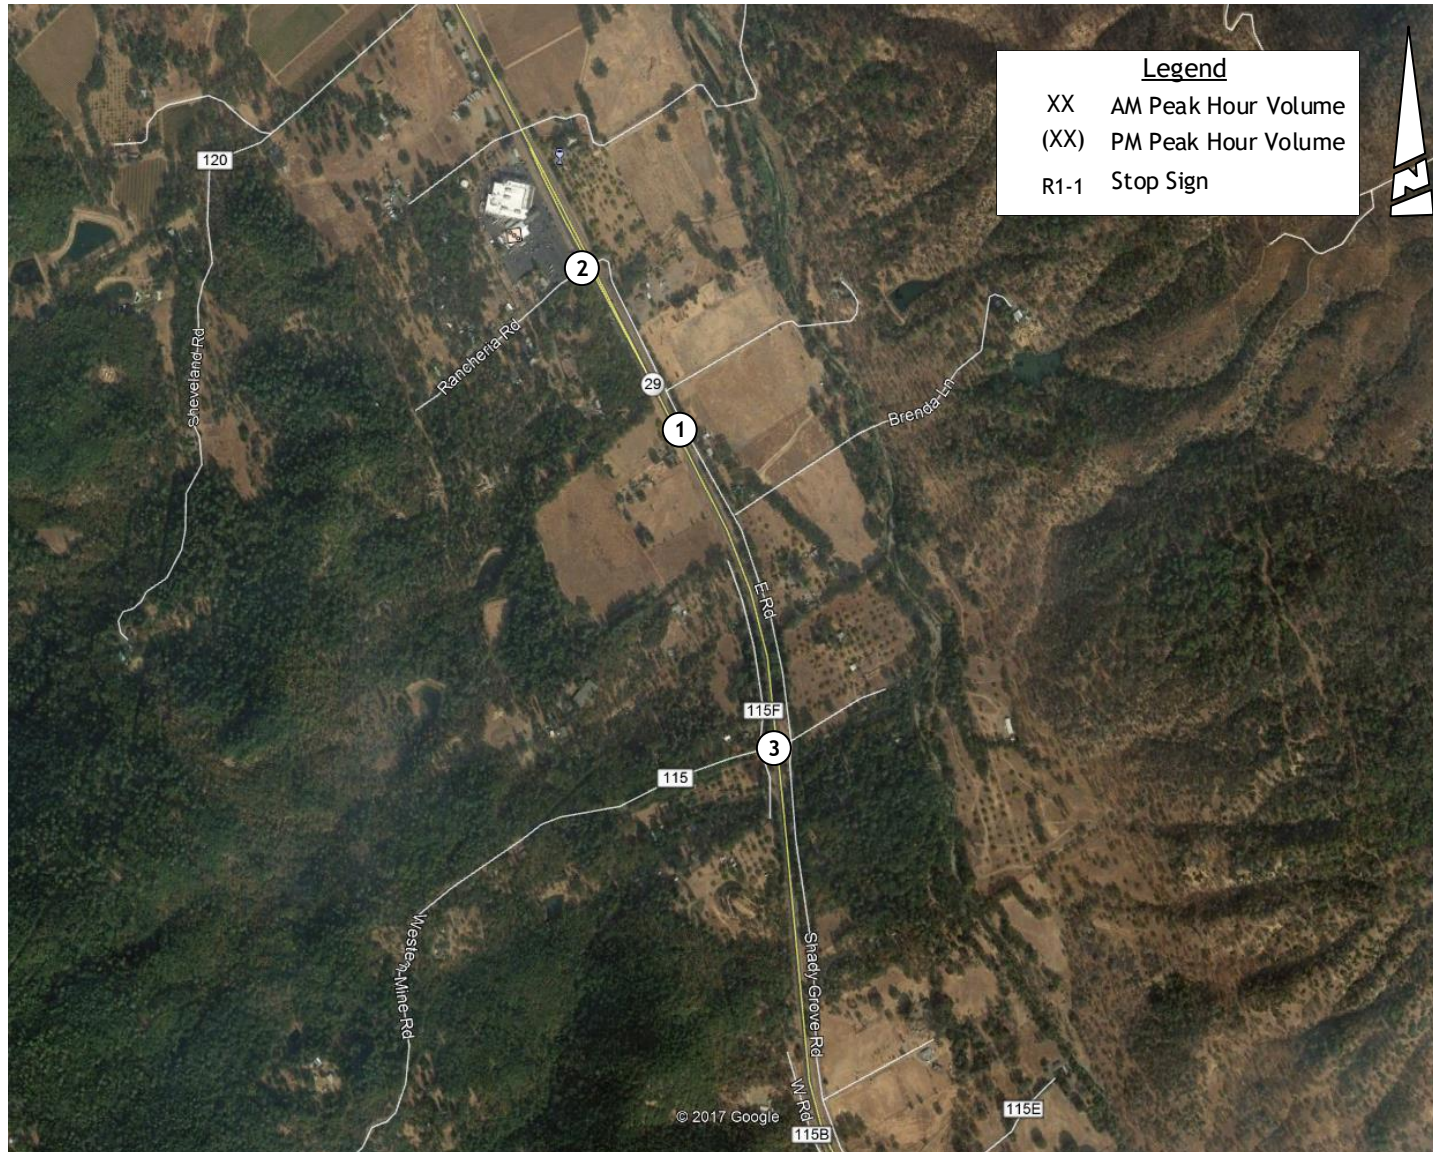
**CUMULATIVE PLUS PROJECT TRAFFIC VOLUMES AND LANE CONFIGURATIONS
REDUCED DENSITY ALTERNATIVE WITH ACCESS OPTION 1**
